Manhole Inspection Summary

Manhole # S49M__021MH

Insp Date: **12/3/08 11:20 AM**

Location Address: **2500 boston st**

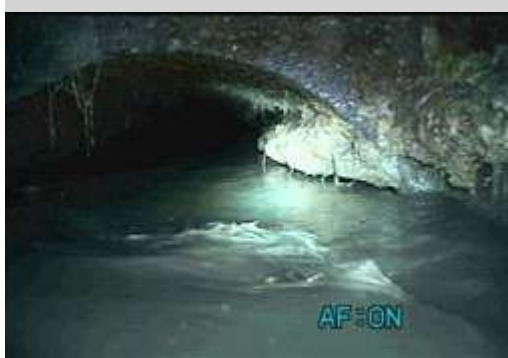
channel debris

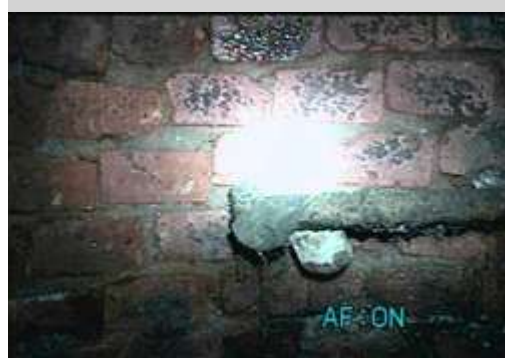
Defect 7

Surcharge ☒ **Evidence Of Surcharge** Depth: **14** (ft.) ☐ Active Surcharge Present

surcharge evd

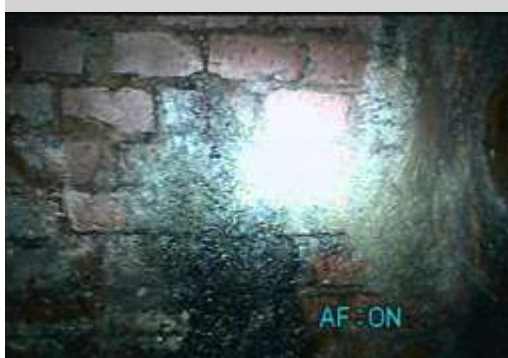
Defect 6

Infiltration: ☐ None ☐ Joint ☐ Cracks ☐ Mortar ☐ Roots ☒ **Wall**

infiltration

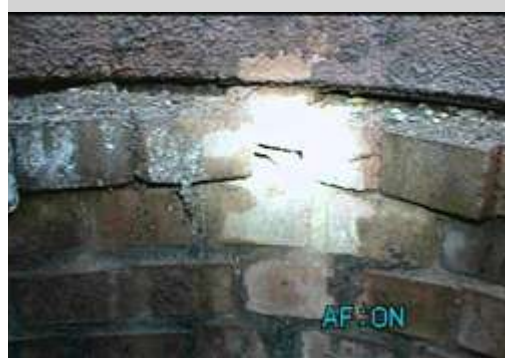
Defect 4

Condition: ☐ Sound ☐ Cracked ☐ Root Intrusion ☒ **Loose Brick** ☐ Deteriorated

Infiltration: ☐ None ☒ **Joint** ☐ Cracks ☐ Mortar ☐ Roots ☐ Wall

frame adj- infiltration and loose bricks

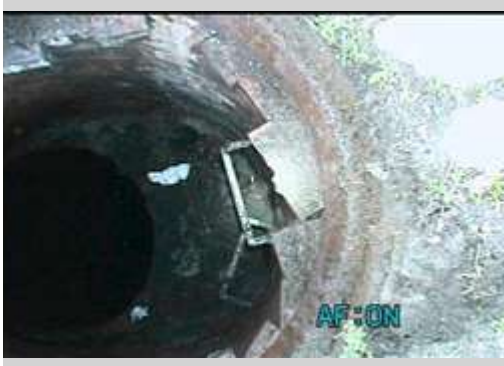
Defect 3

Frame Offset: **4** (in.) Condition: ☒ Sound ☐ Cracked ☐ Leaks

offset

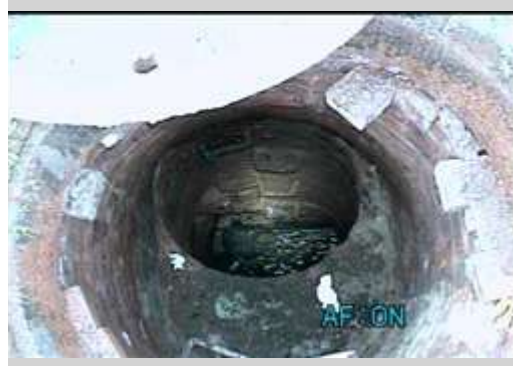
Defect 1

Steps Count: **9** Missing: **0** ☒ **Corroded**

corr steps, loose bricks in chimney

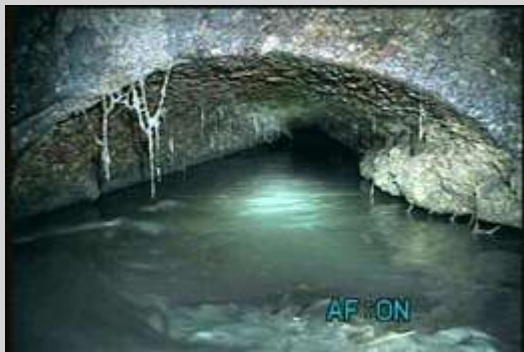
12 O'Clock Outflow

Deposits: ☐ None ☐ Mud ☒ Sludge ☐ Debris ☐ Grease

Silt Depth: 4 (in.) Deposits Extent: Light

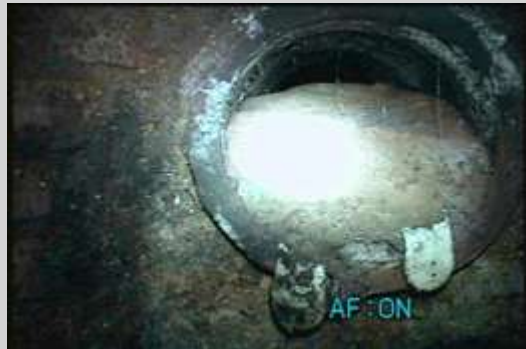
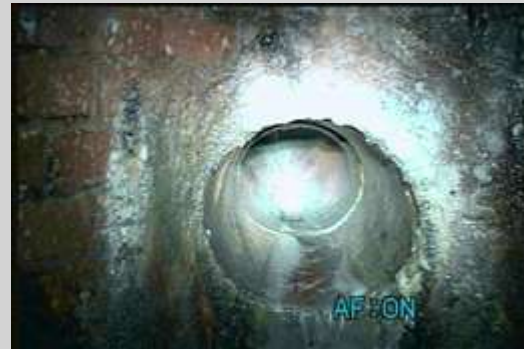
7 O'Clock Inflow

Deposits: ☐ None ☐ Mud ☐ Sludge ☒ **Debris** ☐ Grease

Silt Depth: **10** (in.) Deposits Extent: **Heavy**
